# Situation Photo Log

Tuesday, February 19, 2013

Kalamazoo River / Enbridge Spill

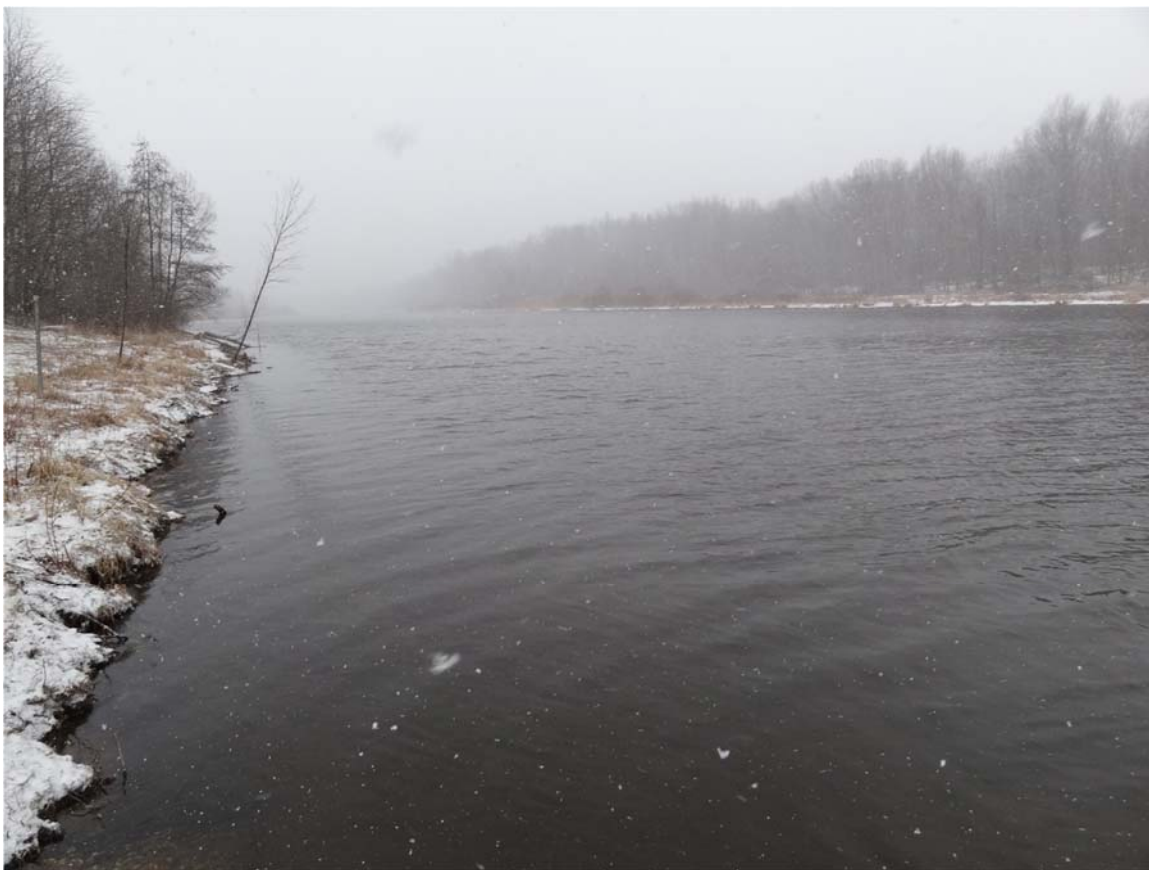
1. C0.4 Boat launch river conditions observed.

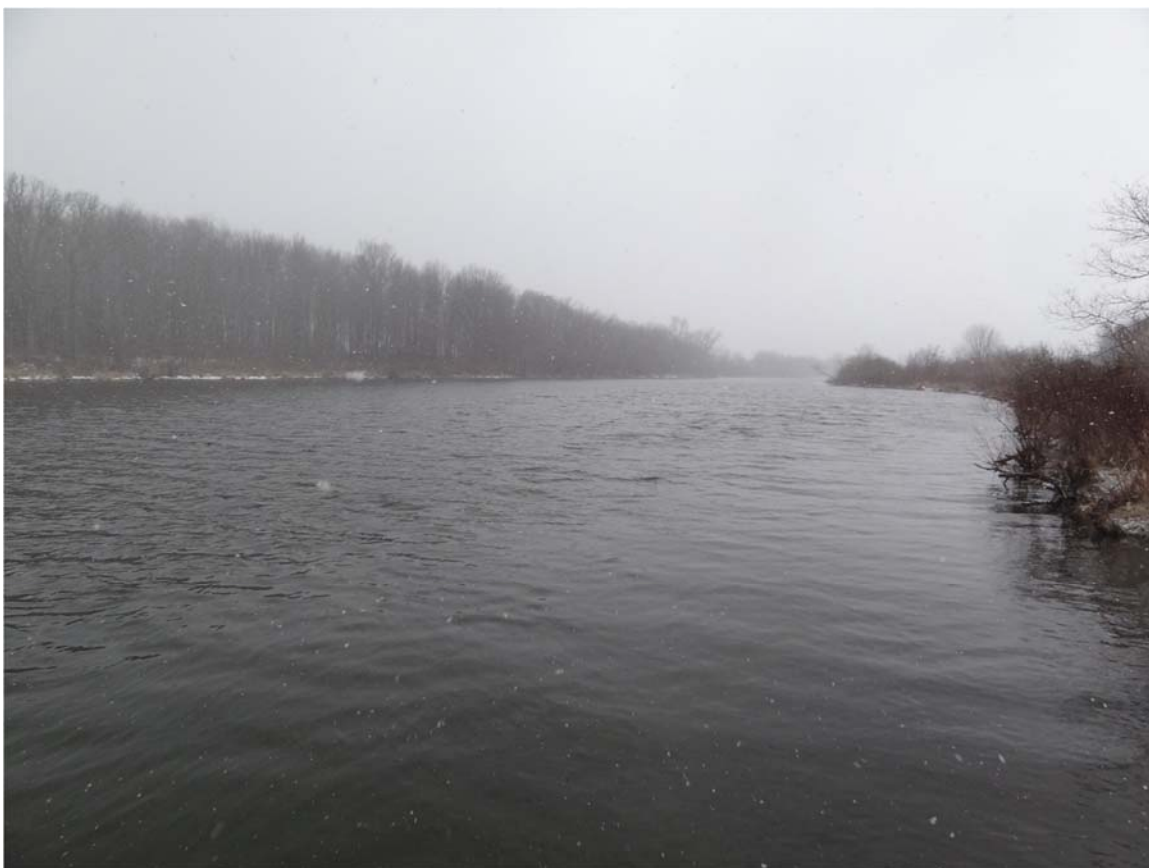
2. C0.4 Boat launch river conditions observed.

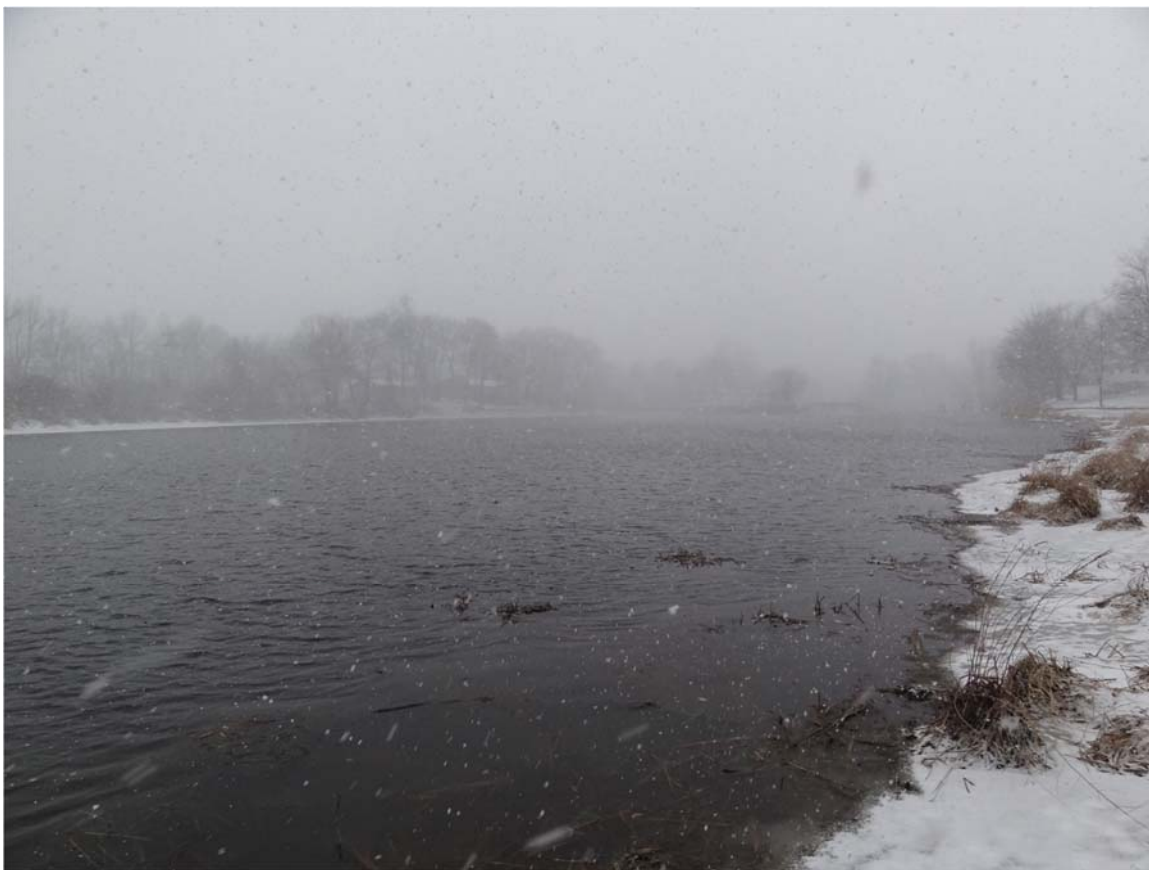
3. MP5.75 Ceresco Dam impoundment river conditions observed.

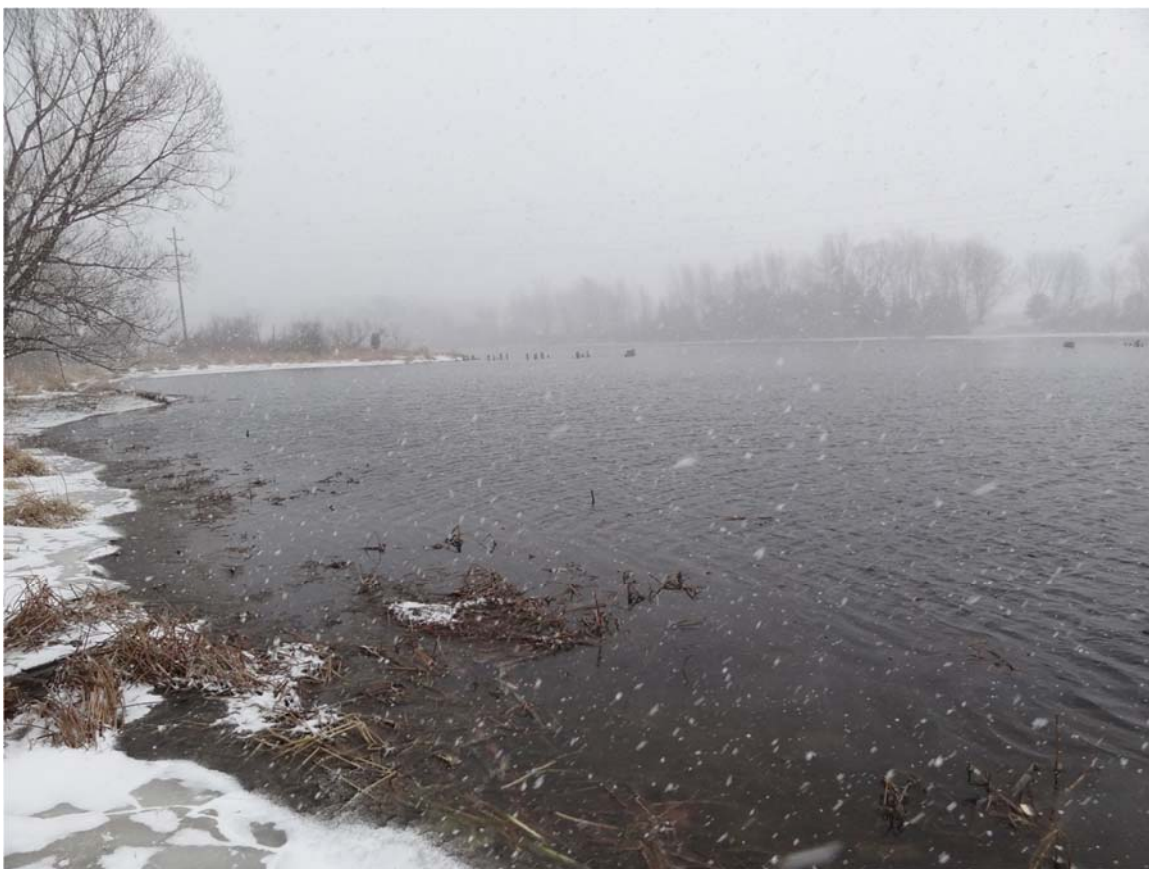
4. MP5.63 Ceresco Dam impoundment river conditions observed.

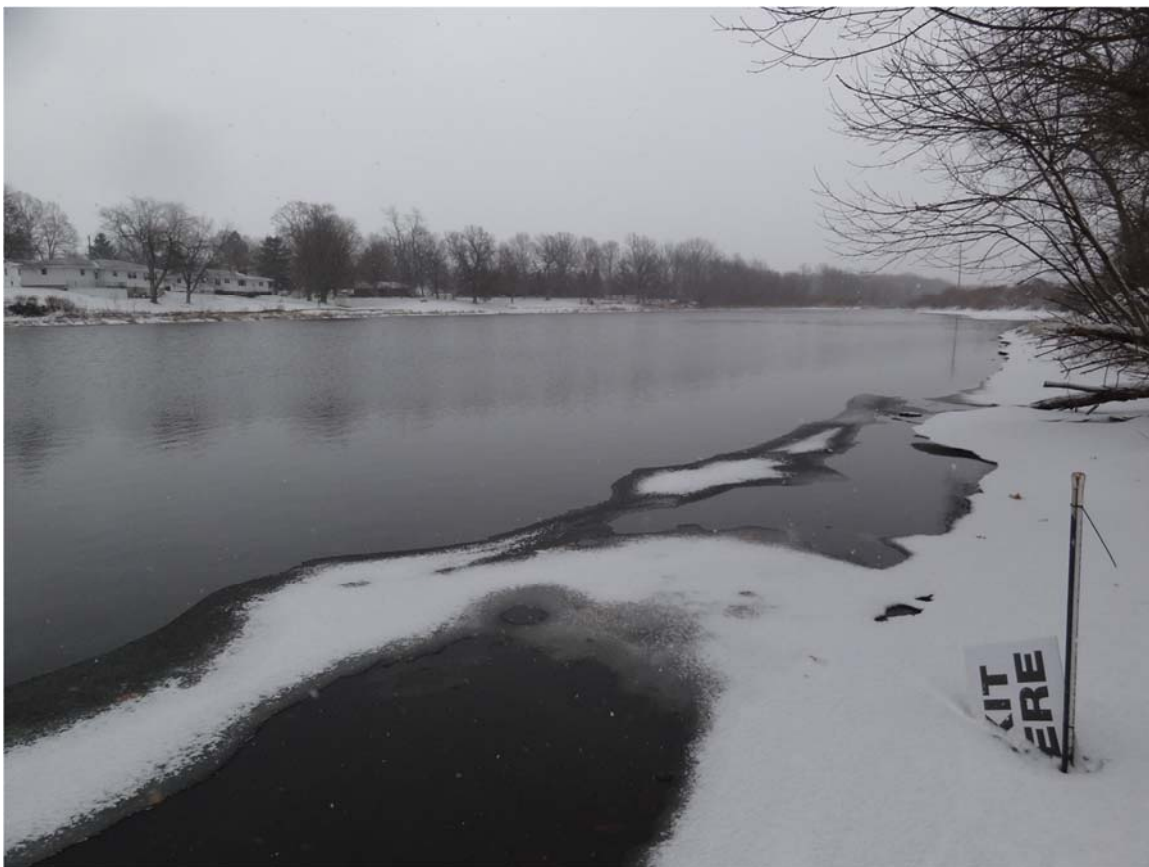
5. Ceresco Dam impoundment river conditions observed.

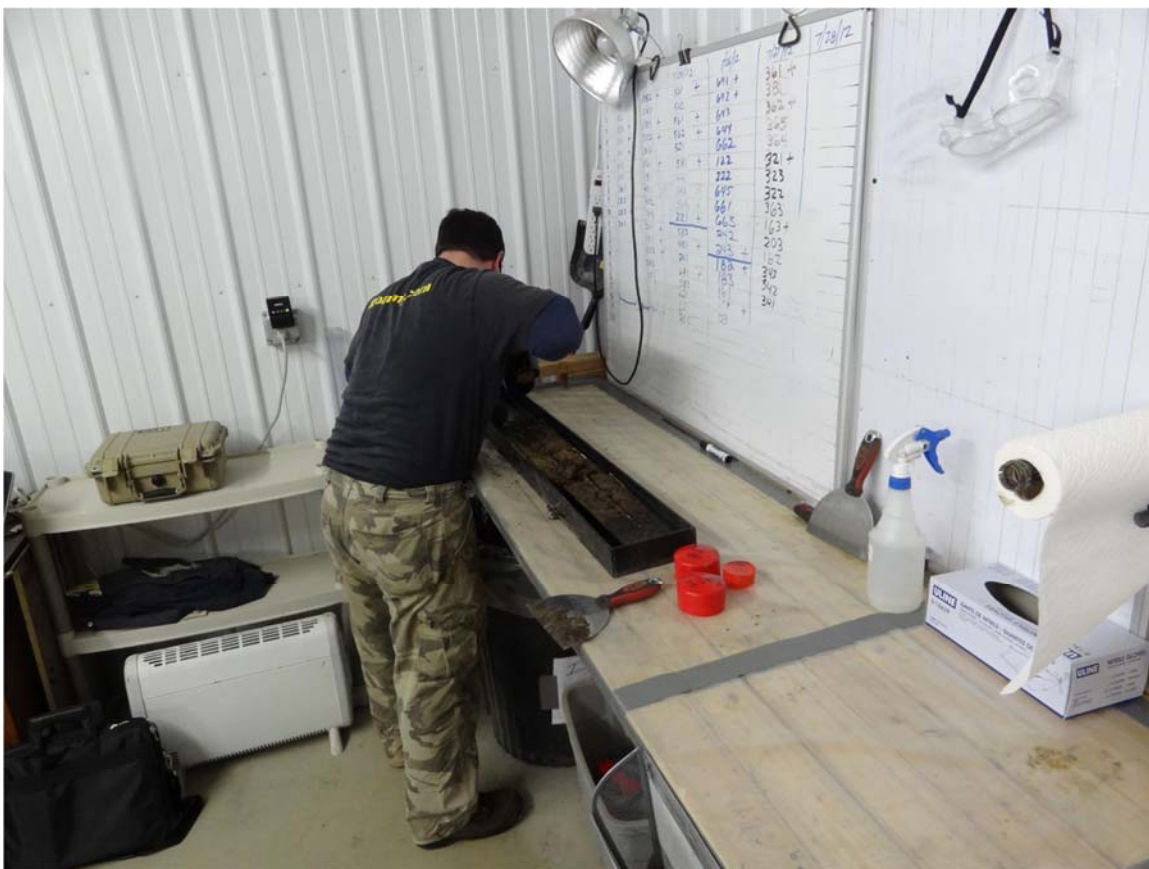
6. C3.2 Pole Barn observed core logging.

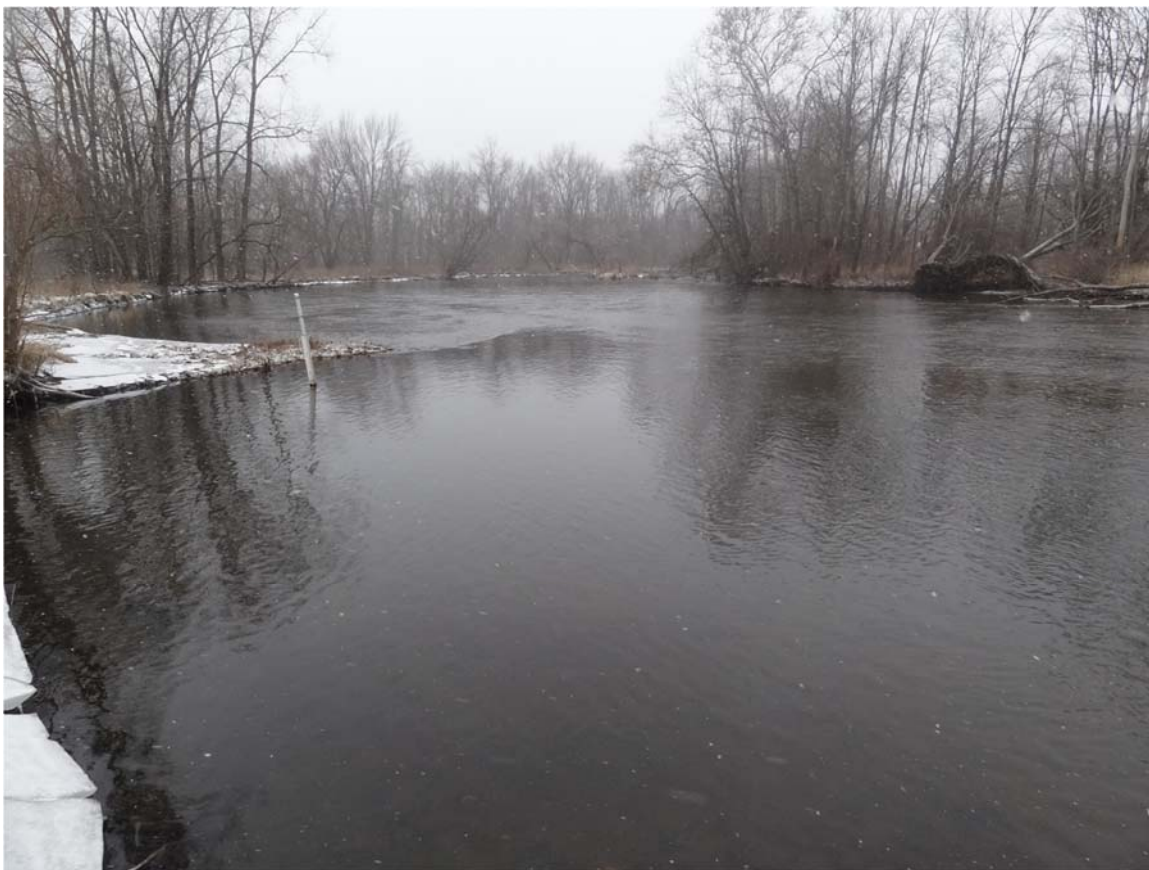
7. C3.2 Observed river conditions.

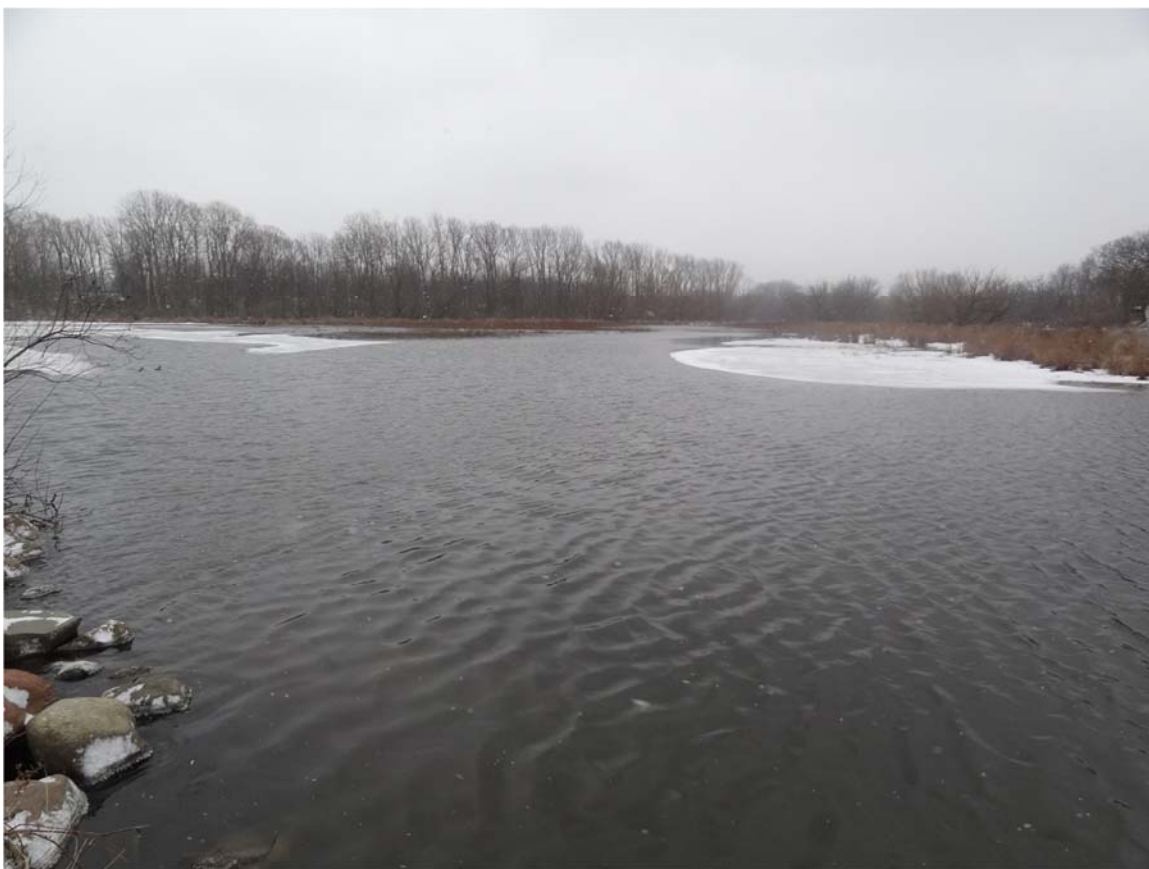
8. MP15.25 South Mill Pond river icing conditions observed.

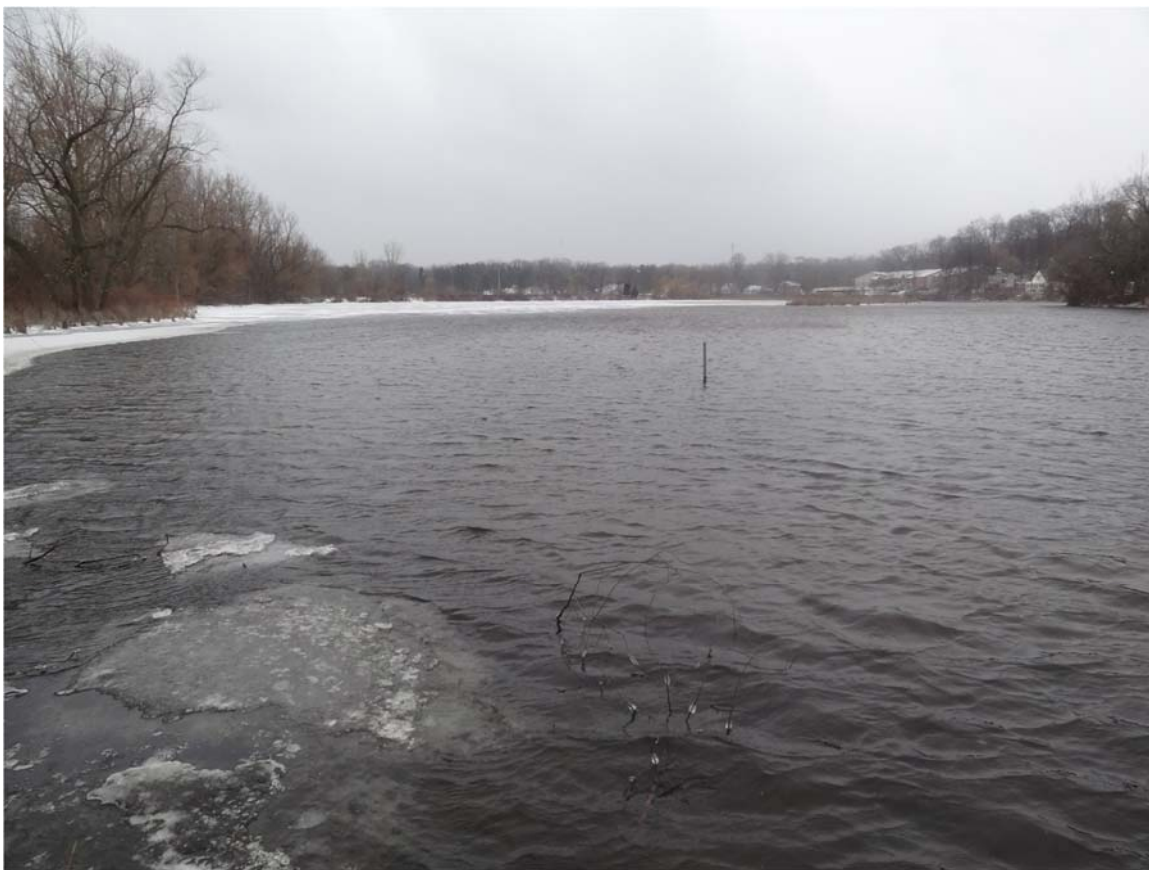
9. MP15.75 North Mill Pond river icing conditions observed.

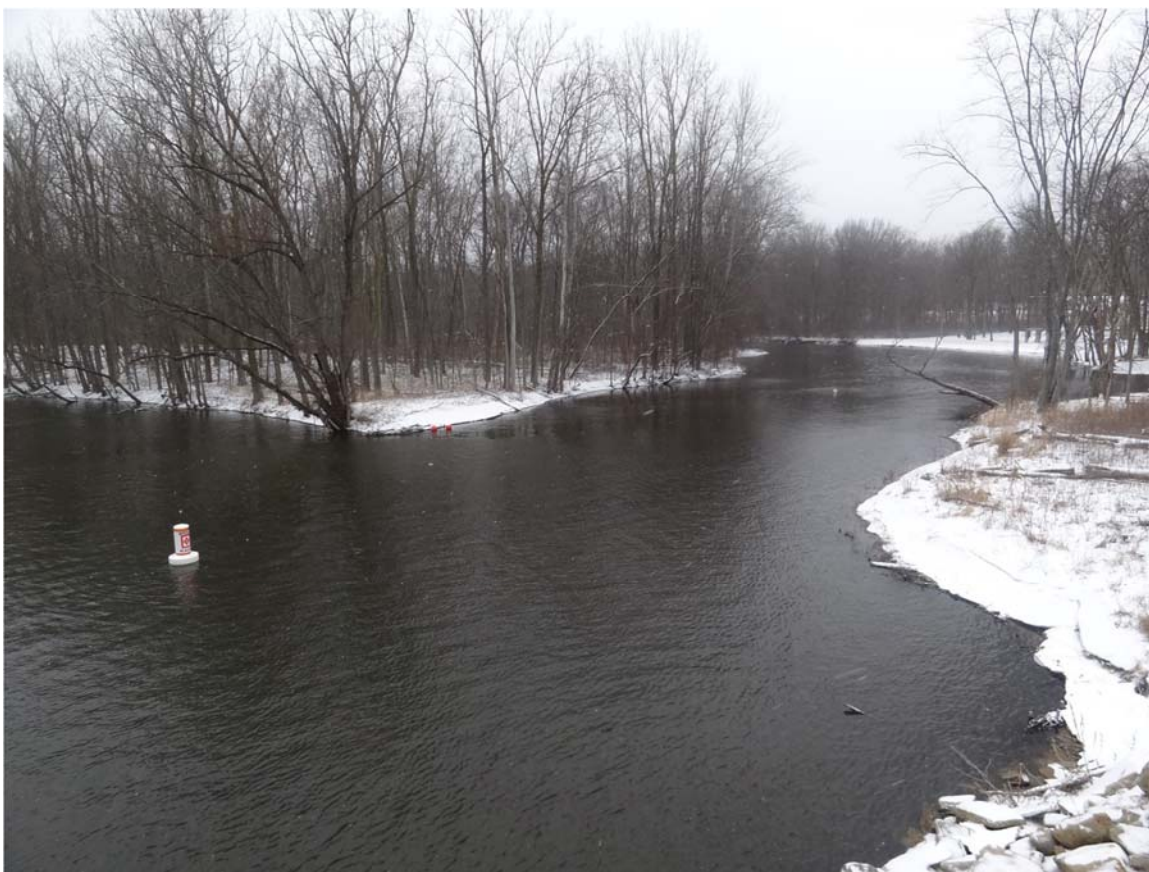
10. MP21.5 River conditions observed.

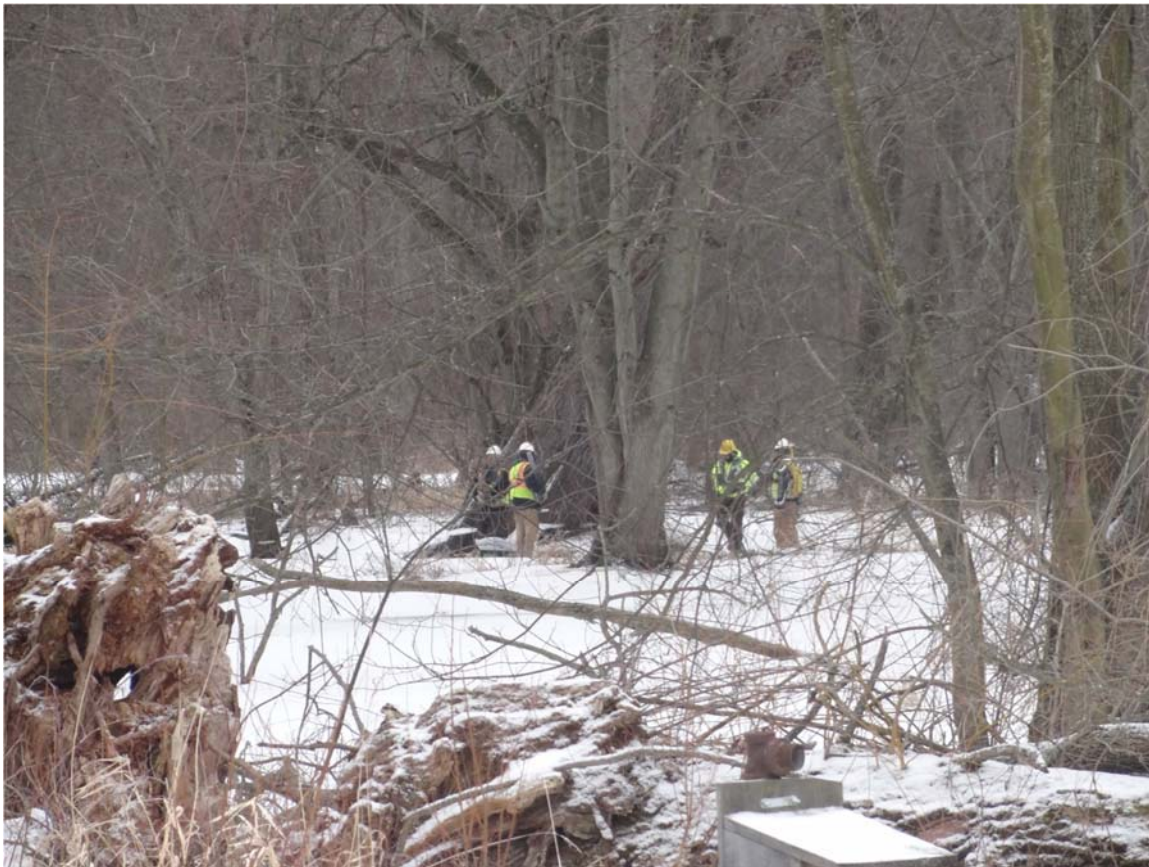
11. MP26.25 RDB observed the RI crew.

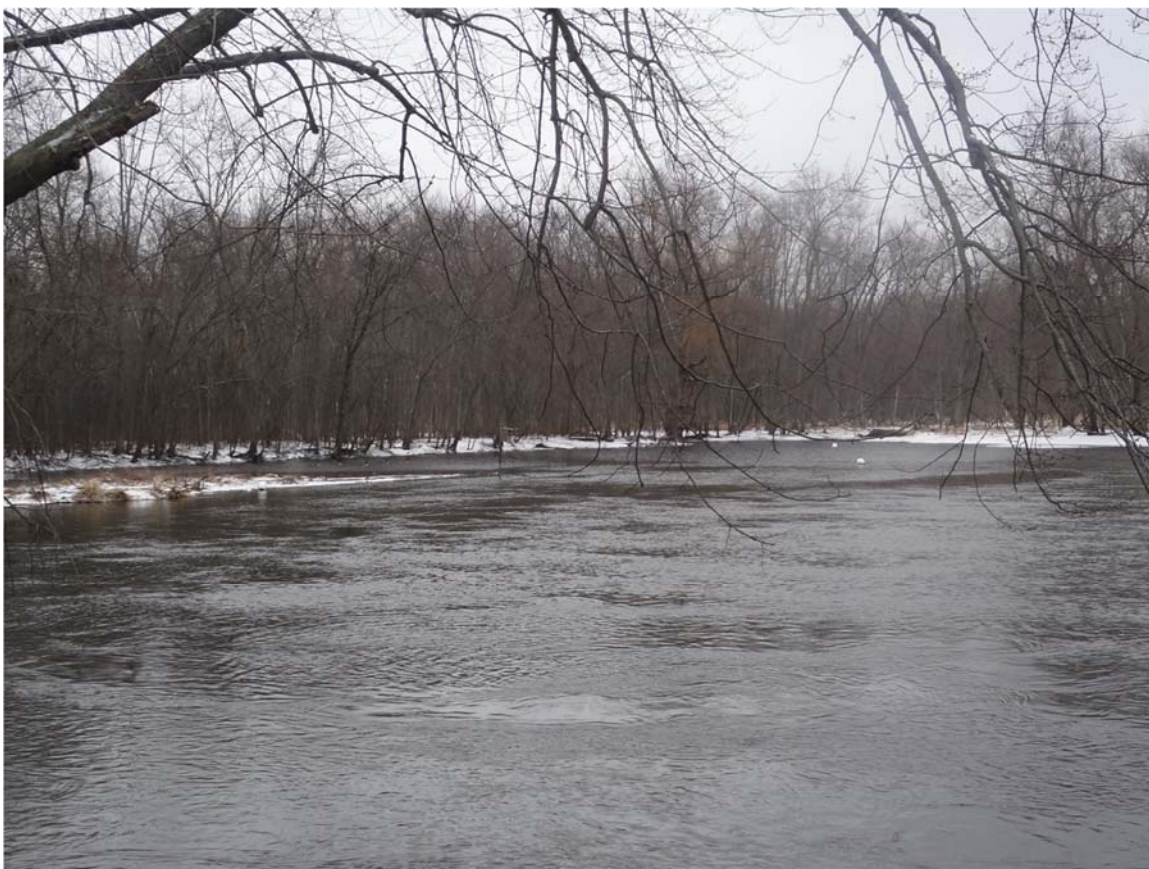
12. MP26.0 Sediment trap river conditions.

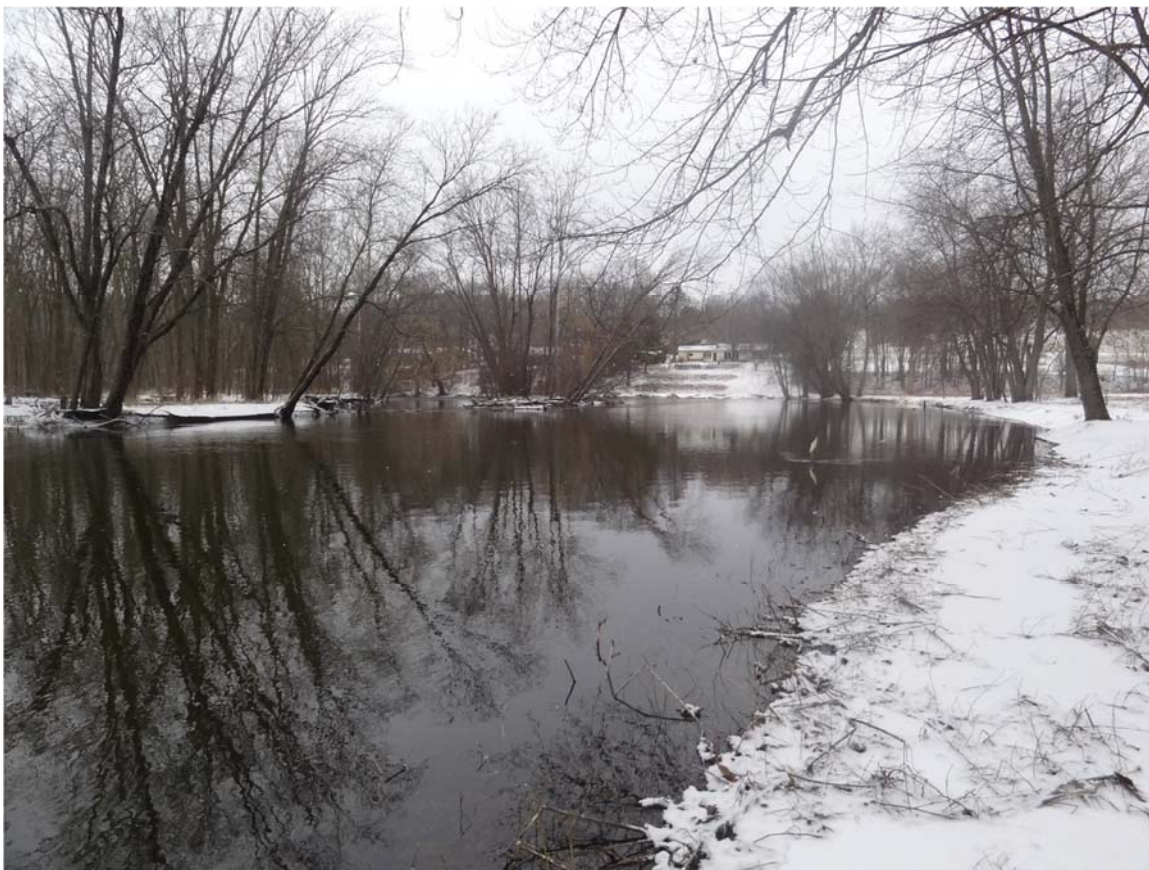
**13. MP27.0 Shady Bend Campground river conditions observed.**

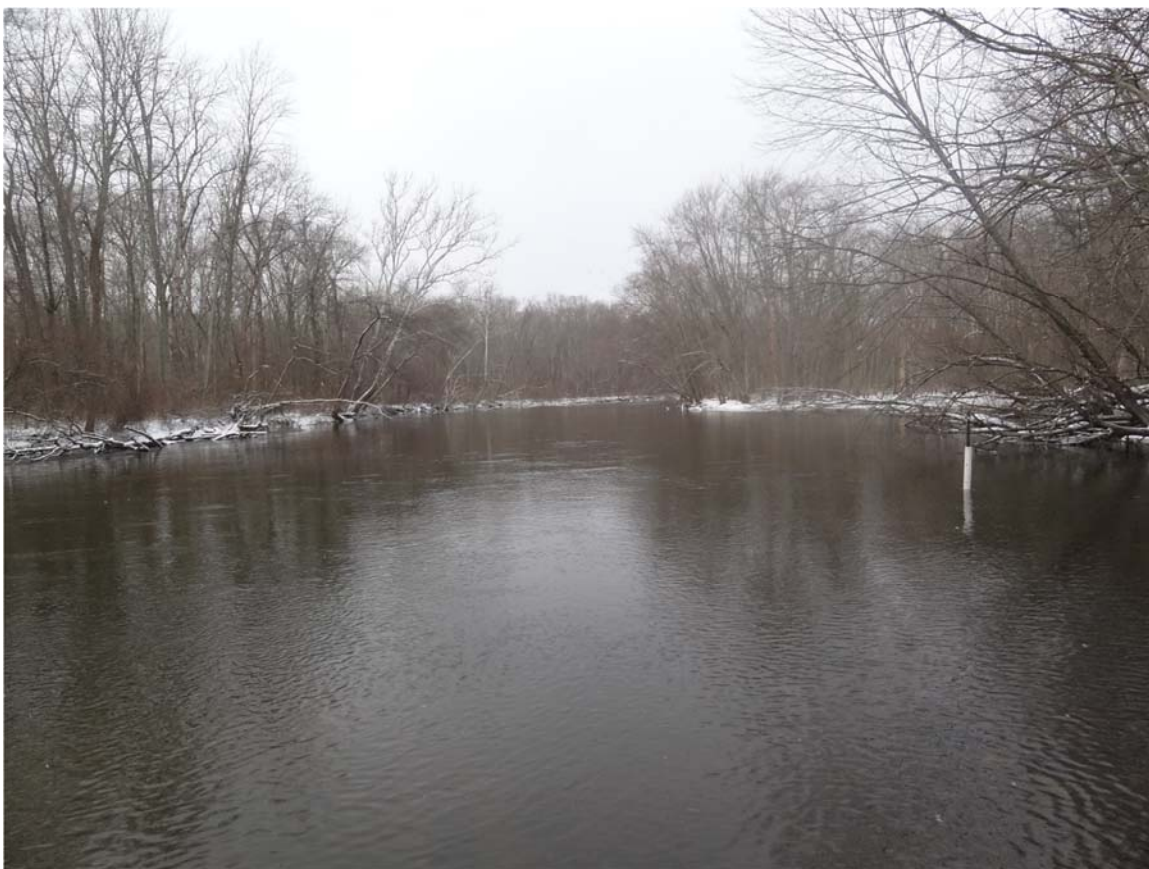
**14. E2 Boat launch observed river conditions.**

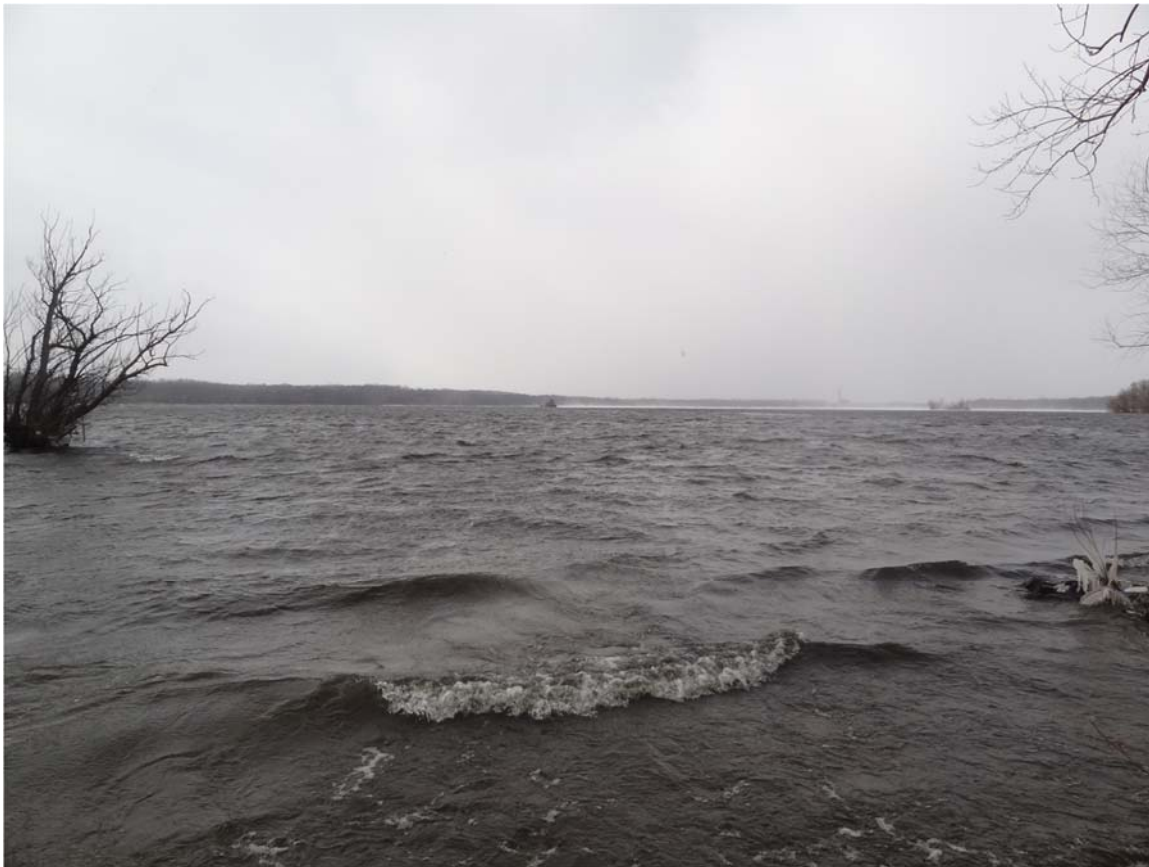
**15. Morrow Lake water conditions.**

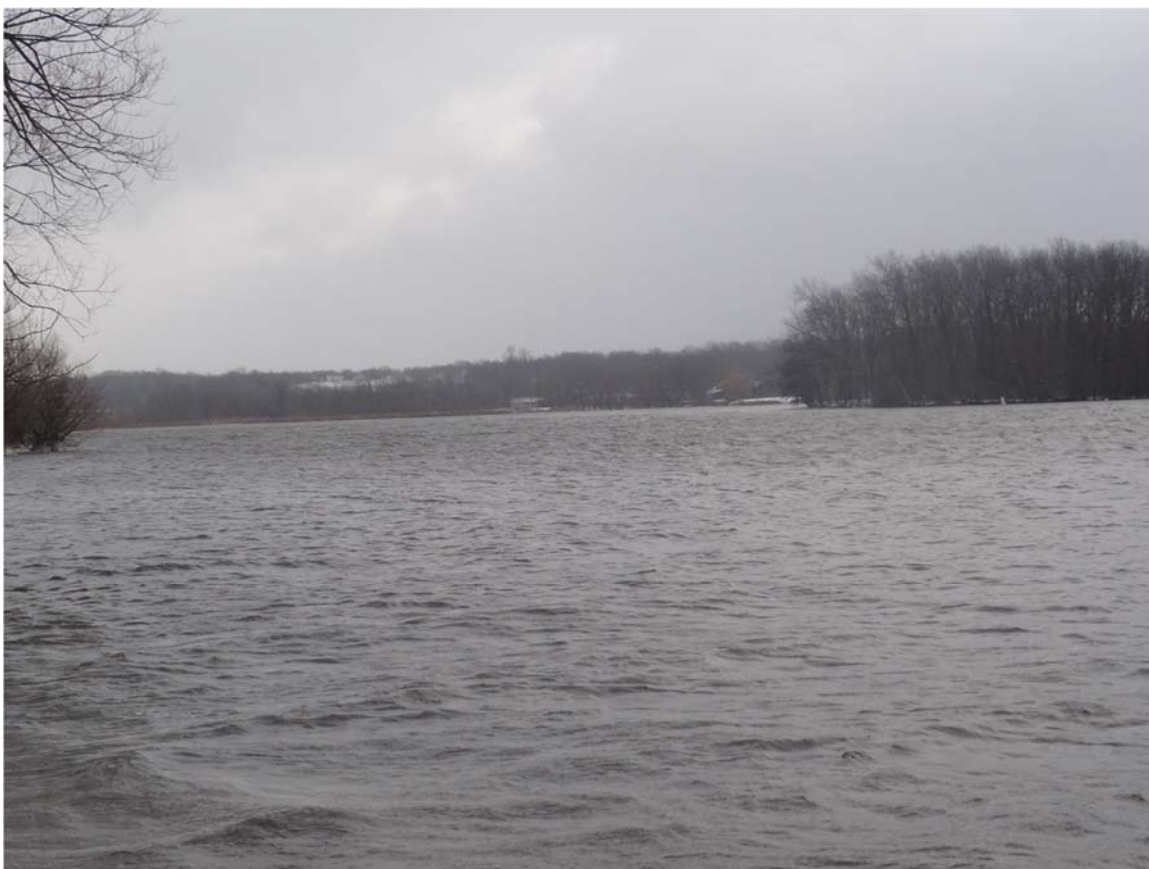
**16. Morrow Lake Delta Neck river conditions observed.**

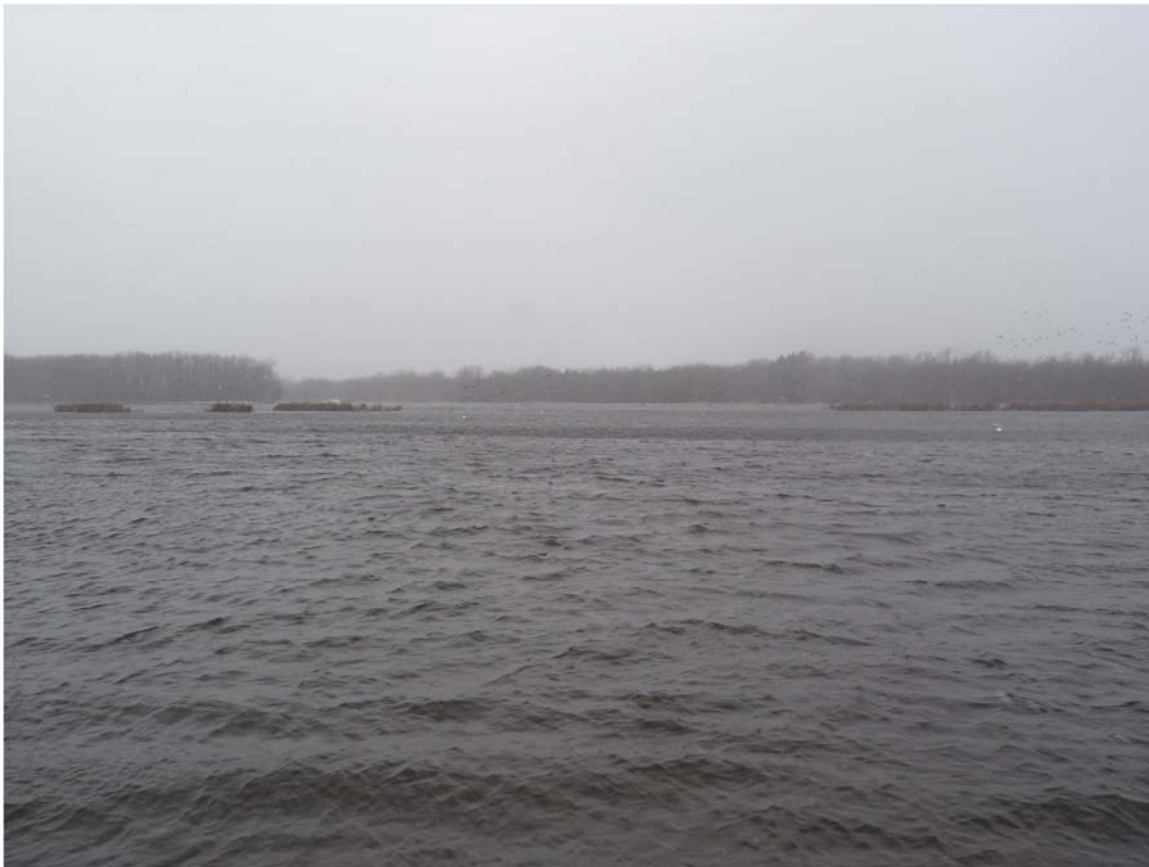
17. Morrow Lake Delta river conditions observed.

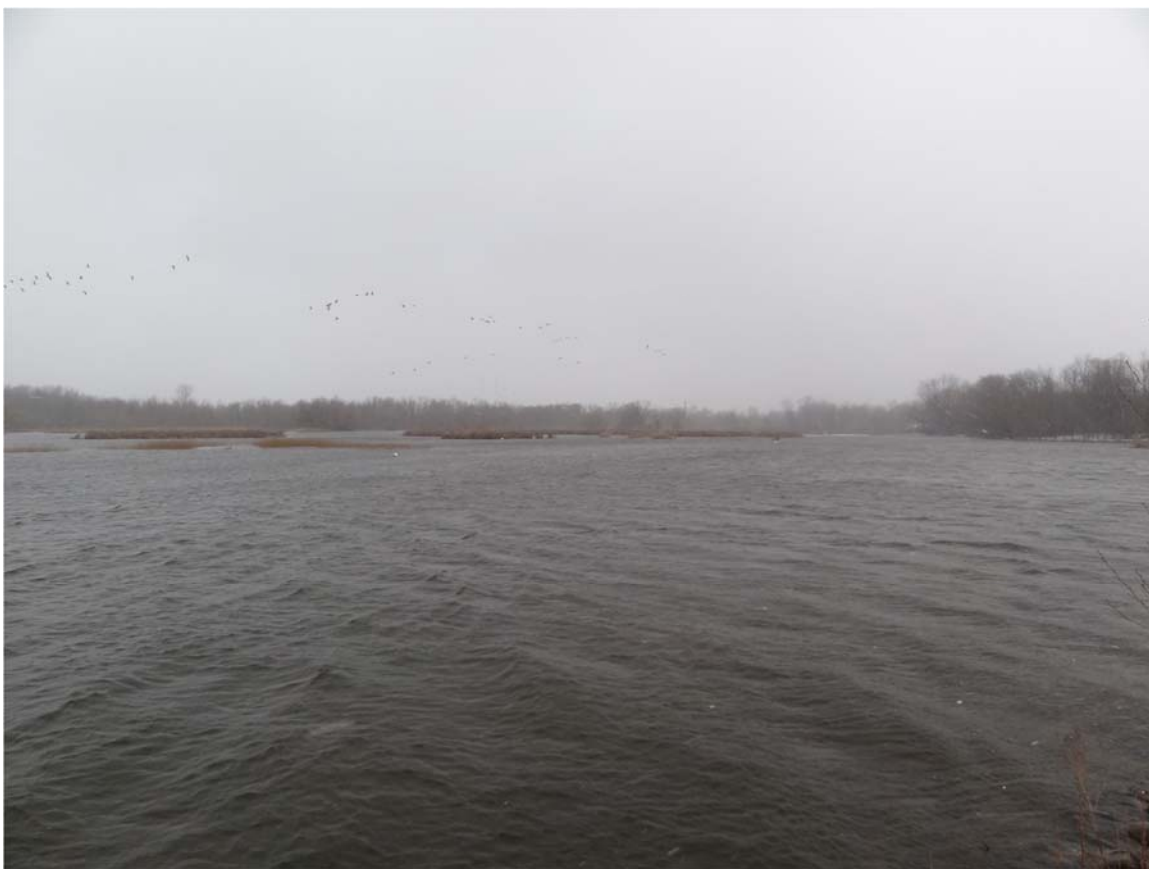
18. Morrow Lake Delta river conditions observed.

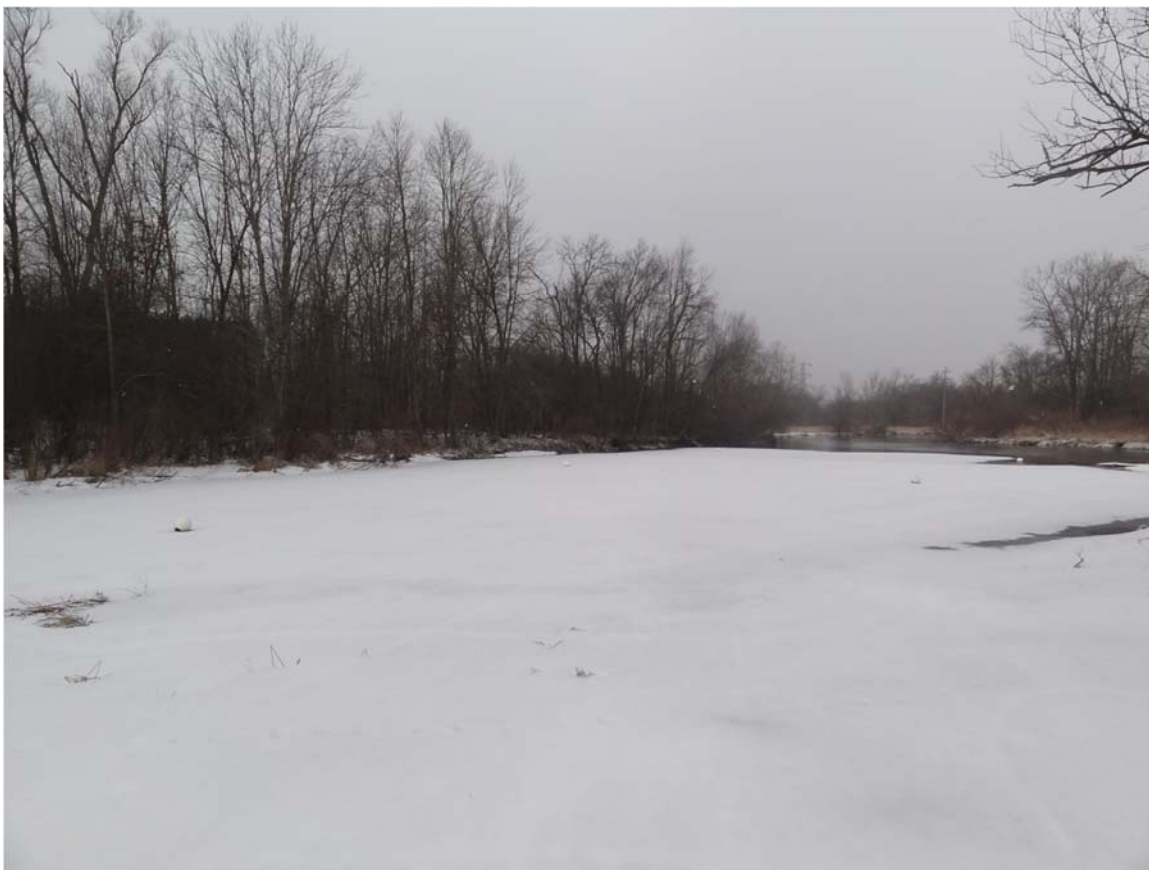
**19. MP10.5 Sediment trap icing conditions observed.**

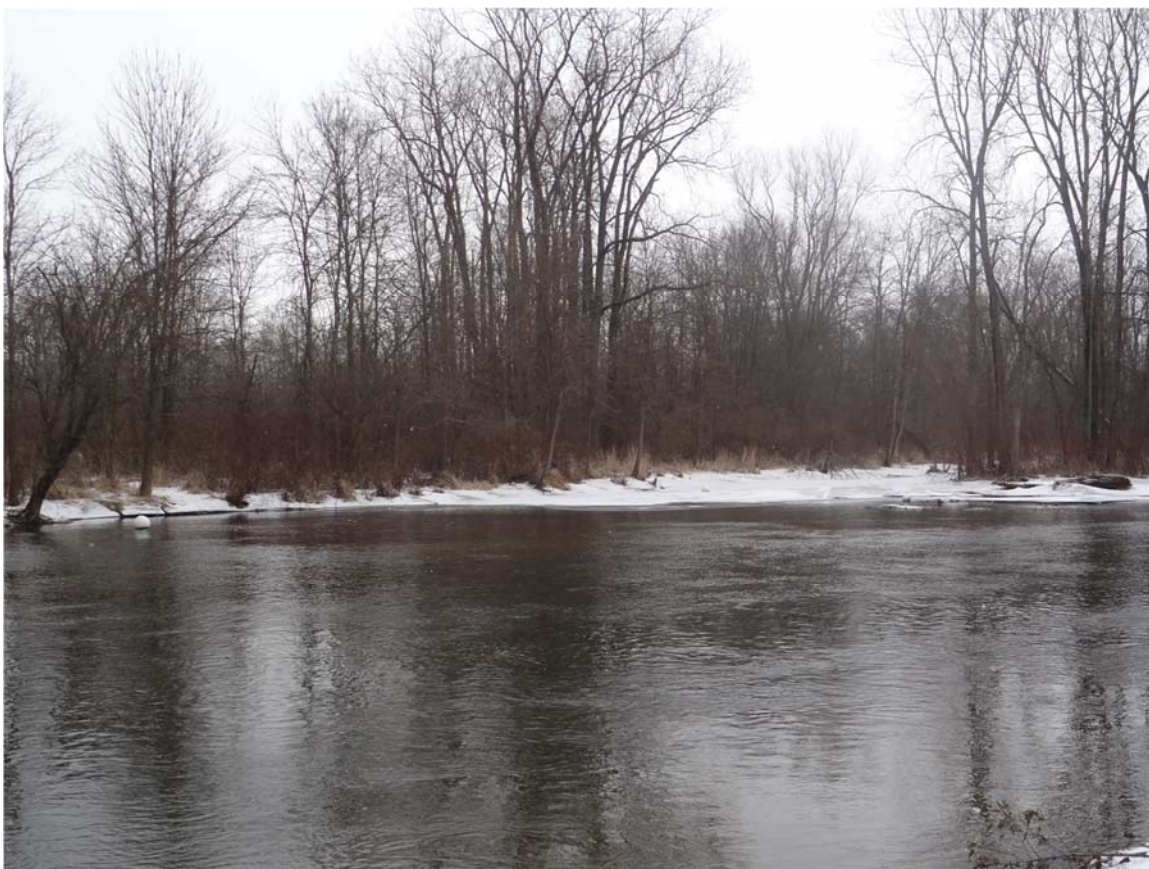
**20. MP10.4 Sediment trap icing conditions observed.**
